# Manhole Inspection Summary

Manhole # S21C1\_021MH

Insp Date: **5/21/08 12:14 PM**

**Location** Address: **2627 paca st**

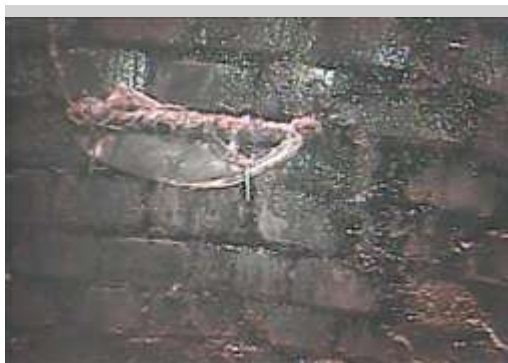
Defect 7

☒ **Evidence Of Surcharge**

Depth: **4** (ft.) ☐ Active Surcharge Present

surcharge evidence

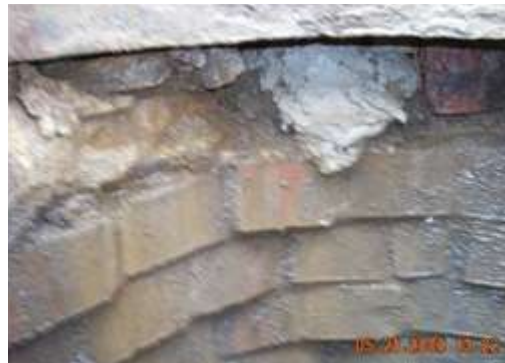
Defect 6

Condition: ☐ Sound ☐ Cracked ☐ Root Intrusion ☐ Loose Brick ☒ **Deteriorated**

deteriorated chimney

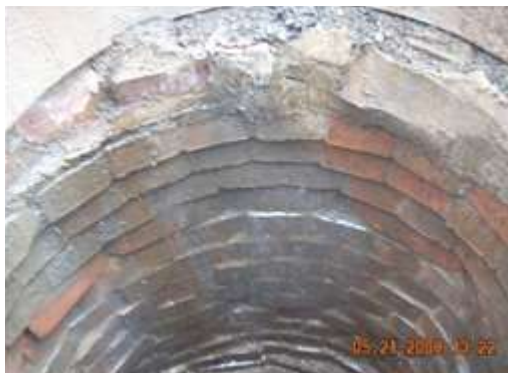
Defect 5

Infiltration: ☐ None ☒ **Joint** ☐ Cracks ☐ Mortar ☐ Roots ☐ Wall

infiltration @ chimney/frame joint

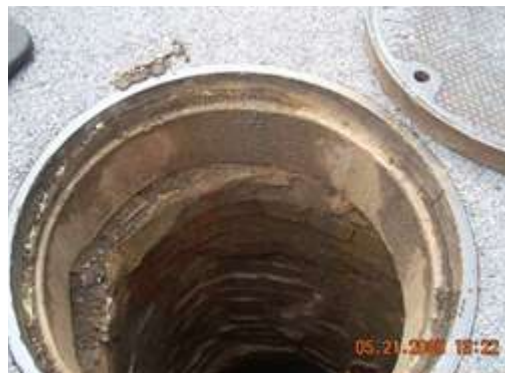
Defect 4

Subject To Ponding: **Sheeting**

☒ **Leaks**

inflow evidence from sheeting (frame leaks)

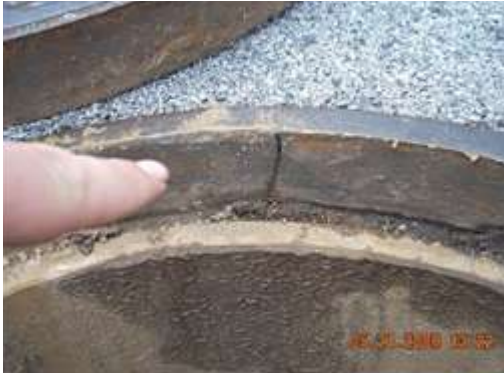
Defect 3

☒ **Cracked**

cracked frame

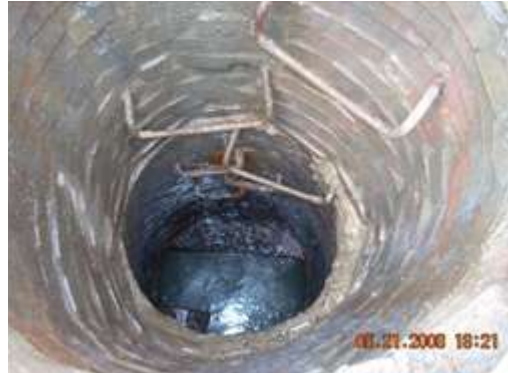
Defect 2

Count: **10** Missing: **0** ☒ **Corroded**

corroded steps

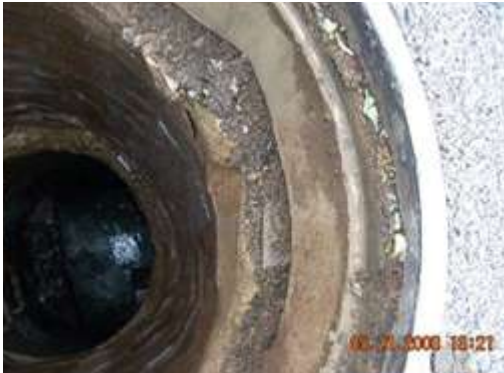
Defect 1

Offset: **2** (in.)

frame offset

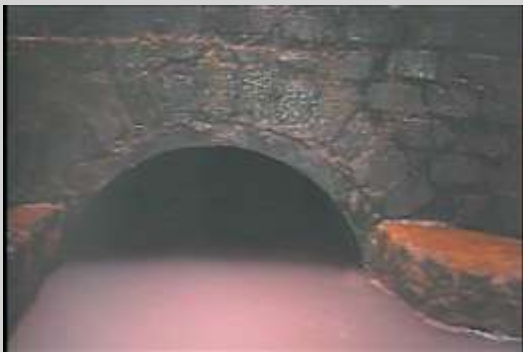
12 O'Clock Outflow

Pipe Height: **24** (in.) Rod and Bar (Angled)  
Pipe Material: **Clay** ☐ Pipe Lined  
Invert Depth: **16.37** (ft.) Flow Characteristics: **Fast**  
Deposits: ☐ None ☐ Mud ☐ Sludge ☒ **Debris** ☐ Grease  
Silt Depth: **4** (in.) Deposits Extent: **Light**  
Infiltration: **None** Pipe Seal Cond: **Sound**

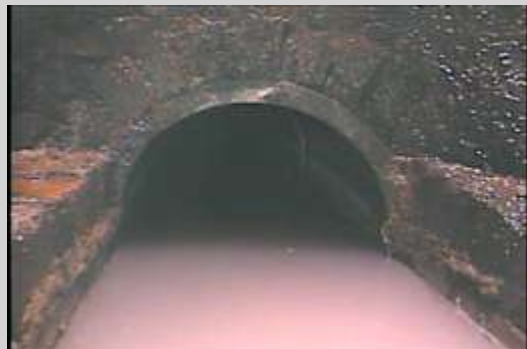
6 O'Clock Inflow

Infiltration: **None** Pipe Seal Cond: **Cracked**
